Quantification des dommages causés par un impact à faible vitesse dans les stratifiés composites à l'aide de l'imagerie par impulsion térahertz

Quantification of Low Velocity Impact Damage in Composite Laminates with Terahertz Pulsed Imaging

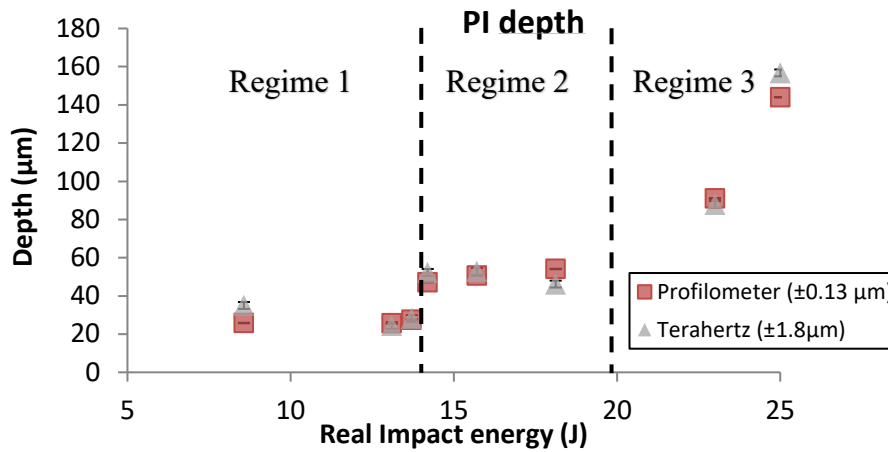
Figure 1: Comparison of PI depth using optical profilometry and THz imaging shows that both methods largely agree and reveal three impact-energy regimes. Initially, PI depth increases with impact energy, then stabilizes, and at high impact energy, PI depth increases significantly.

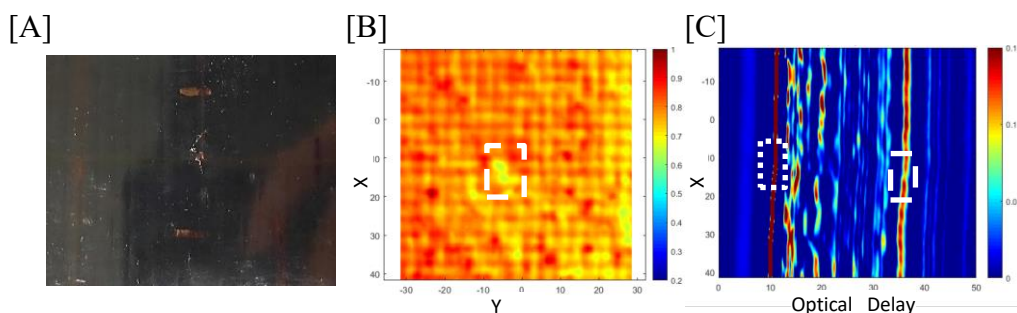
Figure 2: Analysis of the sample impacted at 14.2 J. [A]: Photograph of the non-impacted surface showing matrix cracking (dashed box). [B]: THz C-scan of the non-impacted surface showing matrix cracking as decreased amplitude. [C]: THz B-scans showing damage mechanisms: dotted box for PI, dashed box for bottom surface cracking.

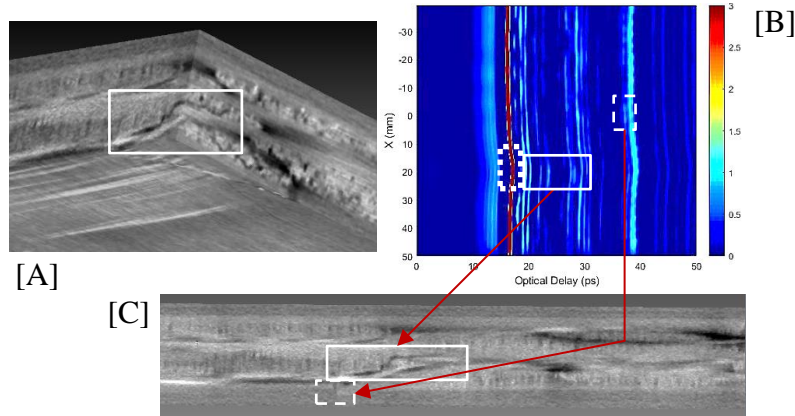
Figure 3: Analysis of the sample impacted at 23 J. [A]: X-ray tomography image showing a crack propagating to the second ply. [B]: THz B-scan near the impacted region. [C]: X-ray tomography image near the impacted region. Multiple types of damage are visible: dotted box for Permanent Indentation (PI), dashed box for bottom surface cracks, and solid line box for delamination in the third layer.

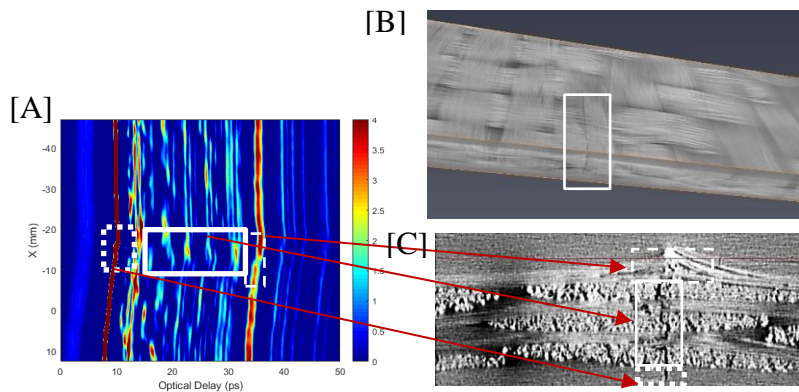
Figure 4: Analysis of the sample impacted at 25 J. A: THz B-scan near the impacted region. B: X-ray tomography image showing matrix cracks running from the non-impacted surface to the other in 3D. C: Longitudinal slice of the X-ray tomography image. Various damage types are visible: dotted box for permanent indentation (PI) + matrix cracks, dashed box for cracks on the bottom surface, and solid line box for delamination.

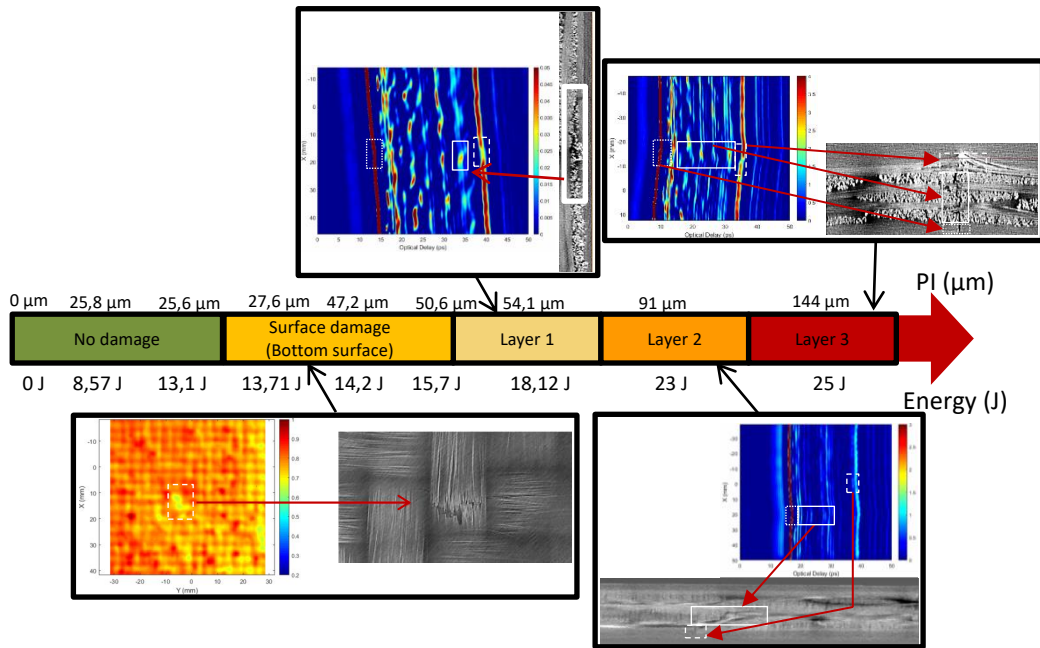
Figure 5: Summary of the damage scenario for the studied material during impact events. The propagation of damage through the sample is indicated. Impact energy and PI depth are also provided.
